# CASE STUDY

Earth bond cable  
clamp force  
monitoring

TfL Victoria Line  
Rolling Stock

## Clamp force monitoring of earth bond cable fasteners

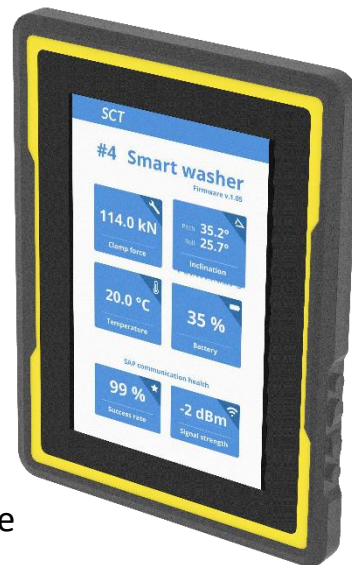
An M10 variant of the Smart Washer was deployed at the Northumberland Park Depot to evaluate the clamp force achieved at installation. The Smart Washers were configured with a fast sampling regime, with clamp force sensor data being captured and stored in the Smart Reader – a ruggedised handheld tablet. The technology was setup in less than 5 minutes and over a morning session, all the major contributing factors which could affect the torque/ bolt tension relationship were evaluated.
